| Manhole | | | |
|---|---|---|---|
| Upstream MH | A6 | Rim to Invert (U) | |
| Downstream MH | A5 | Rim to Invert (D) | |
| Pipe Use | Sanitary Sewage Pipe | Direction of Survey | Upstream |

| Project | | | |
|---|---|---|---|
| Work Order | | Project | Parkside Estates |

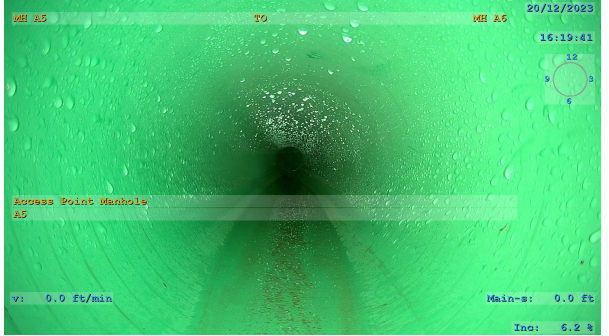
| Distance | Fault Observation | Time | Picture |
|---|---|---|---|
| 0 | Access Point Manhole<br>Severity: None<br>Remarks: A5 | 00:00:23 | A video frame showing the interior of an access point manhole. The walls are wet and greenish. A circular manhole cover is visible in the center. Text overlays include: 'MH A5', 'TO', 'MH A6', '20/12/2023', '16:19:41', 'Access Point Manhole A5', 'v: 0.0 ft/min', 'Main-s: 0.0 ft', and 'Inq: 6.2 %'. |

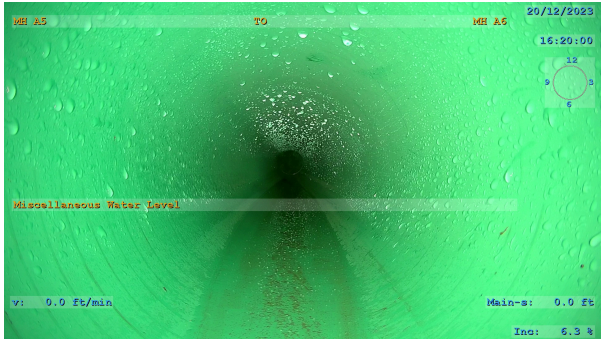
| Distance | Fault Observation | Time | Picture |
|---|---|---|---|
| 0 | Miscellaneous Water Level<br>Severity: None<br>Percent: 5 | 00:00:36 | A video frame showing the interior of a miscellaneous water level. The walls are wet and greenish. A circular manhole cover is visible in the center. Text overlays include: 'MH A5', 'TO', 'MH A6', '20/12/2023', '16:20:00', 'Miscellaneous Water Level', 'v: 0.0 ft/min', 'Main-s: 0.0 ft', and 'Inq: 6.3 %'. |

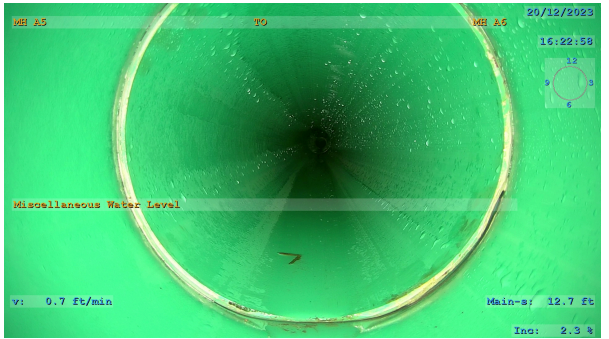
| Distance | Fault Observation | Time | Picture |
|---|---|---|---|
| 12.4 | Miscellaneous Water Level<br>Severity: None<br>Percent: 0 | 00:02:50 | A video frame showing the interior of a miscellaneous water level. The walls are wet and greenish. A circular manhole cover is visible in the center. Text overlays include: 'MH A5', 'TO', 'MH A6', '20/12/2023', '16:22:58', 'Miscellaneous Water Level', 'v: 0.7 ft/min', 'Main-s: 12.7 ft', and 'Inq: 2.3 %'. |

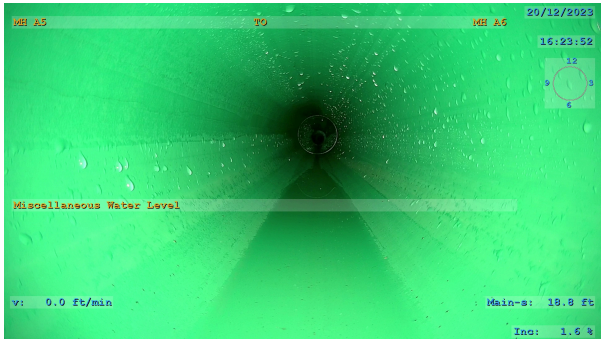
| Distance | Fault Observation | Time | Picture |
|---|---|---|---|
| 18.8 | Miscellaneous Water Level<br>Severity: None<br>Percent: 5 | 00:03:31 | A video frame showing the interior of a miscellaneous water level. The walls are wet and greenish. A circular manhole cover is visible in the center. Text overlays include: 'MH A5', 'TO', 'MH A6', '20/12/2023', '16:23:52', 'Miscellaneous Water Level', 'v: 0.0 ft/min', 'Main-s: 18.8 ft', and 'Inq: 1.6 %'. |

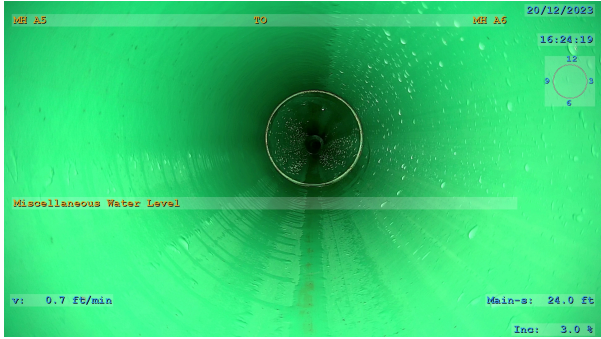
| Distance | Fault Observation | Time | Picture |
|---|---|---|---|
| 23.9 | Miscellaneous Water Level<br>Severity: None<br>Percent: 0 | 00:03:51 | |

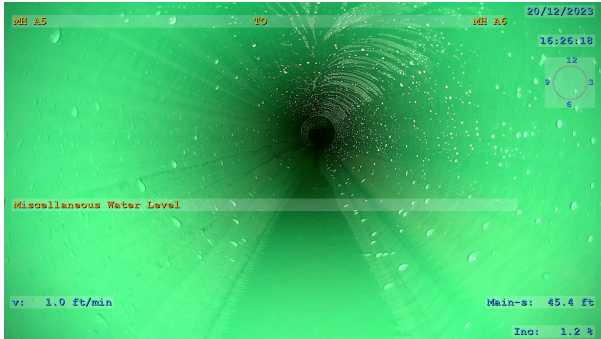
| Distance | Fault Observation | Time | Picture |
|---|---|---|---|
| 45.1 | Miscellaneous Water Level<br>Severity: None<br>Percent: 5 | 00:05:21 | |

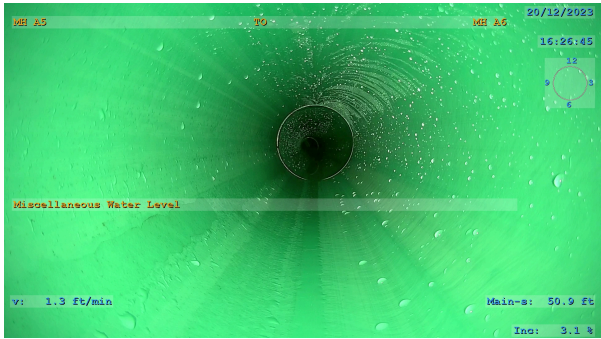
| Distance | Fault Observation | Time | Picture |
|---|---|---|---|
| 50.7 | Miscellaneous Water Level<br>Severity: None<br>Percent: 0 | 00:05:41 | |

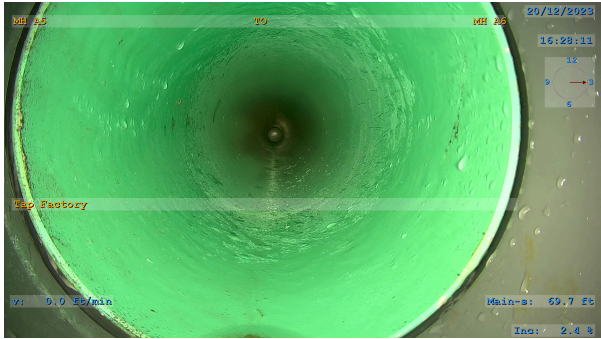
| Distance | Fault Observation | Time | Picture |
|---|---|---|---|
| 69.7 | Tap Factory<br>Severity: None<br>Size: 6<br>Position: 3 | 00:06:45 | |

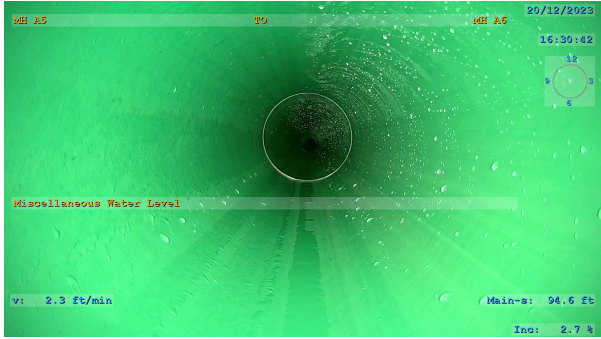
| Distance | Fault Observation | Time | Picture |
|---|---|---|---|
| 94.5 | Miscellaneous Water Level<br>Severity: None<br>Percent: 0 | 00:08:38 | |

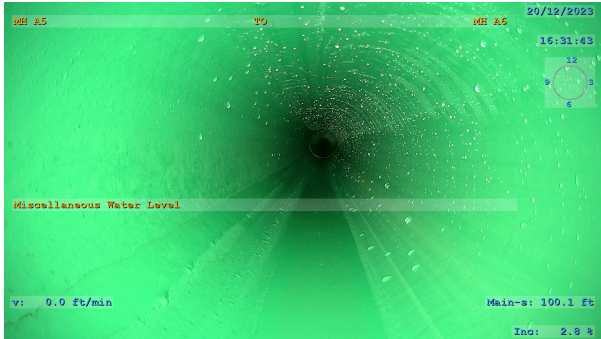
| Distance | Fault Observation | Time | Picture |
|---|---|---|---|
| 100.1 | Miscellaneous Water Level<br>Severity: None<br>Percent: 5 | 00:09:22 | |

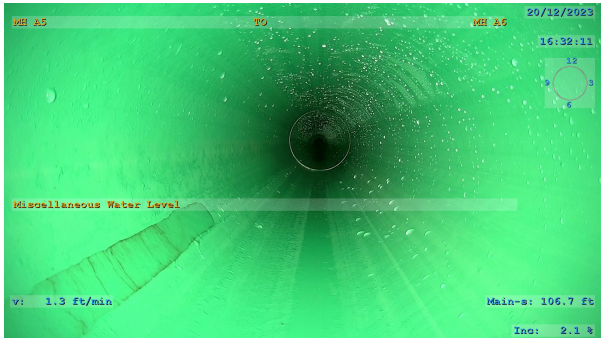
| Distance | Fault Observation | Time | Picture |
|---|---|---|---|
| 106.7 | Miscellaneous Water Level<br>Severity: None<br>Percent: 0 | 00:09:43 | |

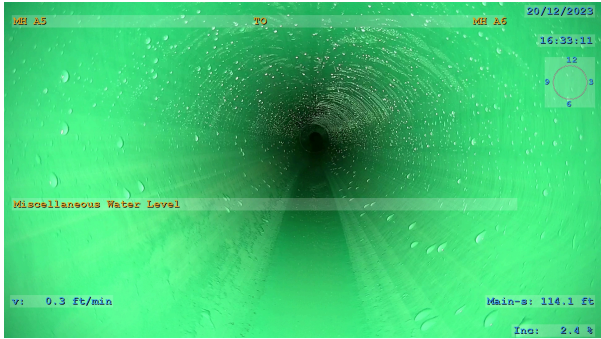
| Distance | Fault Observation | Time | Picture |
|---|---|---|---|
| 114 | Miscellaneous Water Level<br>Severity: None<br>Percent: 5 | 00:10:29 | |

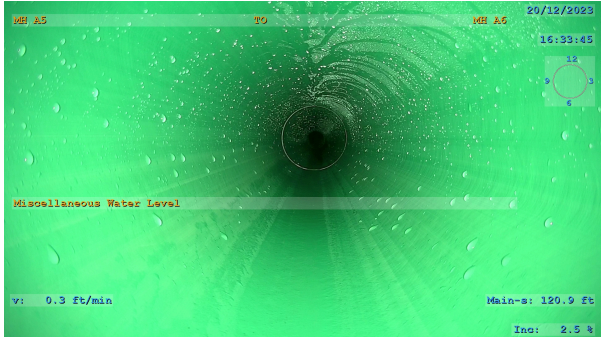
| Distance | Fault Observation | Time | Picture |
|---|---|---|---|
| 120.9 | Miscellaneous Water Level<br>Severity: None<br>Percent: 0 | 00:10:54 | |

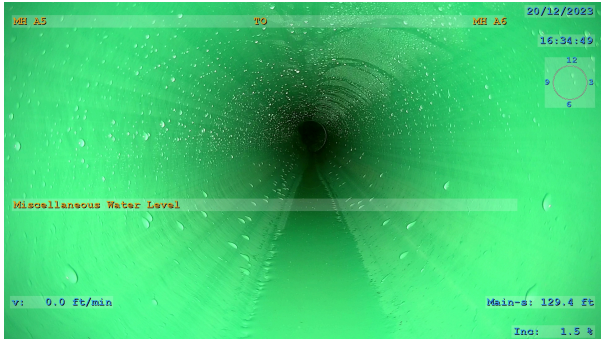
| Distance | Fault Observation | Time | Picture |
|---|---|---|---|
| 129.4 | Miscellaneous Water Level<br>Severity: None<br>Percent: 5 | 00:11:42 | |

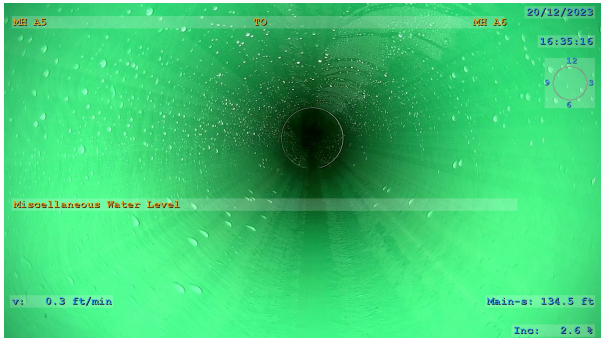
| Distance | Fault Observation | Time | Picture |
|---|---|---|---|
| 134.4 | Miscellaneous Water Level<br>Severity: None<br>Percent: 0 | 00:12:02 | |

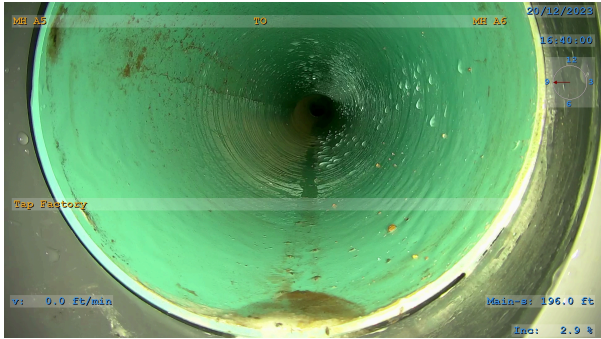
| Distance | Fault Observation | Time | Picture |
|---|---|---|---|
| 196 | Tap Factory<br>Severity: None<br>Size: 6<br>Position: 9 | 00:15:36 | |

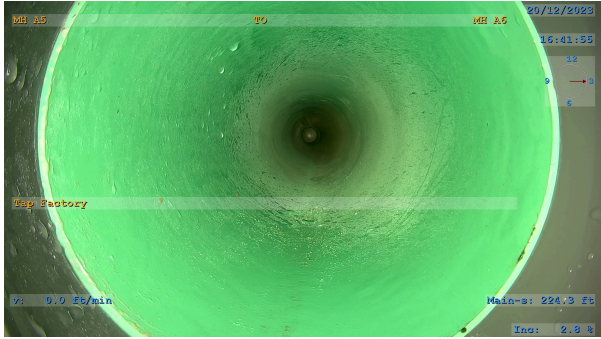
| Distance | Fault Observation | Time | Picture |
|---|---|---|---|
| 224.3 | Tap Factory<br>Severity: None<br>Size: 6<br>Position: 3 | 00:17:02 | A green-tinted video frame showing a circular pipe interior. A horizontal line across the center is labeled 'Tap Factory'. On the right, a small circular inset shows a scale from 0 to 12. Text at the bottom left reads 'v: 0.0 ft/min'. Text at the bottom right reads 'Main-s: 224.3 ft' and 'Ina: 2.3 s'. The top right corner shows the date '20/12/2023' and time '16:41:55'. |

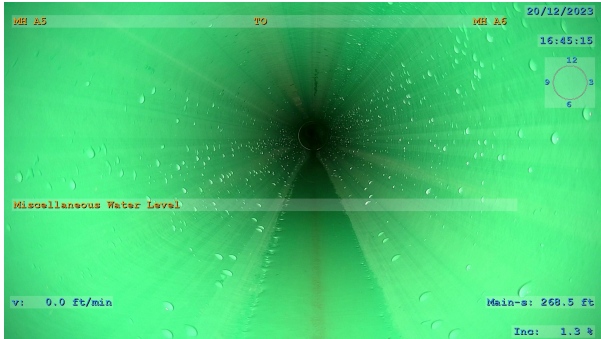
| Distance | Fault Observation | Time | Picture |
|---|---|---|---|
| 268.5 | Miscellaneous Water Level<br>Severity: None<br>Percent: 5 | 00:19:33 | A green-tinted video frame showing a pipe interior with water droplets. A horizontal line across the center is labeled 'Miscellaneous Water Level'. On the right, a small circular inset shows a scale from 0 to 12. Text at the bottom left reads 'v: 0.0 ft/min'. Text at the bottom right reads 'Main-s: 268.5 ft' and 'Ina: 1.3 s'. The top right corner shows the date '20/12/2023' and time '16:45:15'. |

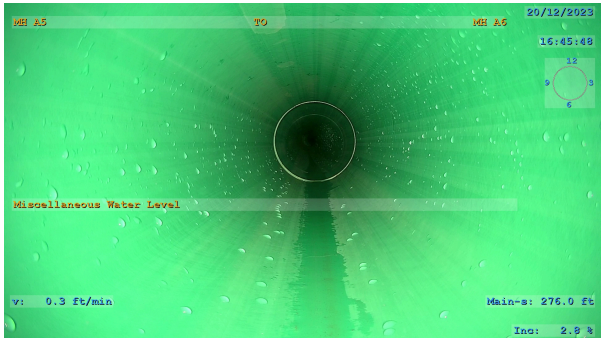
| Distance | Fault Observation | Time | Picture |
|---|---|---|---|
| 276 | Miscellaneous Water Level<br>Severity: None<br>Percent: 0 | 00:19:58 | A green-tinted video frame showing a pipe interior with water droplets. A horizontal line across the center is labeled 'Miscellaneous Water Level'. On the right, a small circular inset shows a scale from 0 to 12. Text at the bottom left reads 'v: 0.3 ft/min'. Text at the bottom right reads 'Main-s: 276.0 ft' and 'Ina: 2.9 s'. The top right corner shows the date '20/12/2023' and time '16:45:49'. |

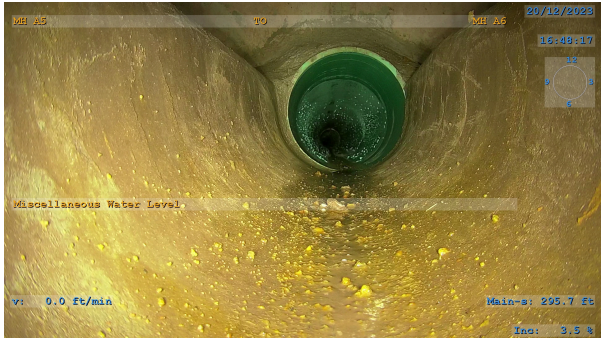
| Distance | Fault Observation | Time | Picture |
|---|---|---|---|
| 295.7 | Miscellaneous Water Level<br>Severity: None<br>Percent: 0 | 00:21:50 | A brown-tinted video frame showing a pipe interior with a dark circular opening. A horizontal line across the center is labeled 'Miscellaneous Water Level'. On the right, a small circular inset shows a scale from 0 to 12. Text at the bottom left reads 'v: 0.0 ft/min'. Text at the bottom right reads 'Main-s: 295.7 ft' and 'Ina: 3.5 s'. The top right corner shows the date '20/12/2023' and time '16:48:17'. |

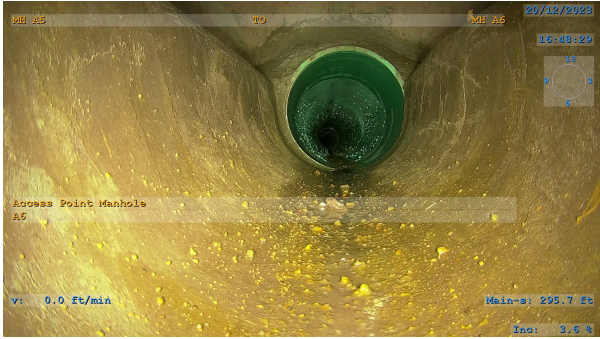
| Distance | Fault Observation | Time | Picture |
|---|---|---|---|
| 295.7 | Access Point<br>Manhole<br>Severity: None<br>Remarks: A6 | 00:21:59 | |
